# **Assessment of Dam Safety of Coal Combustion Surface Impoundments**

**Indianapolis Power & Light Company**

**Petersburg Generating Station**

**November 15, 2010**

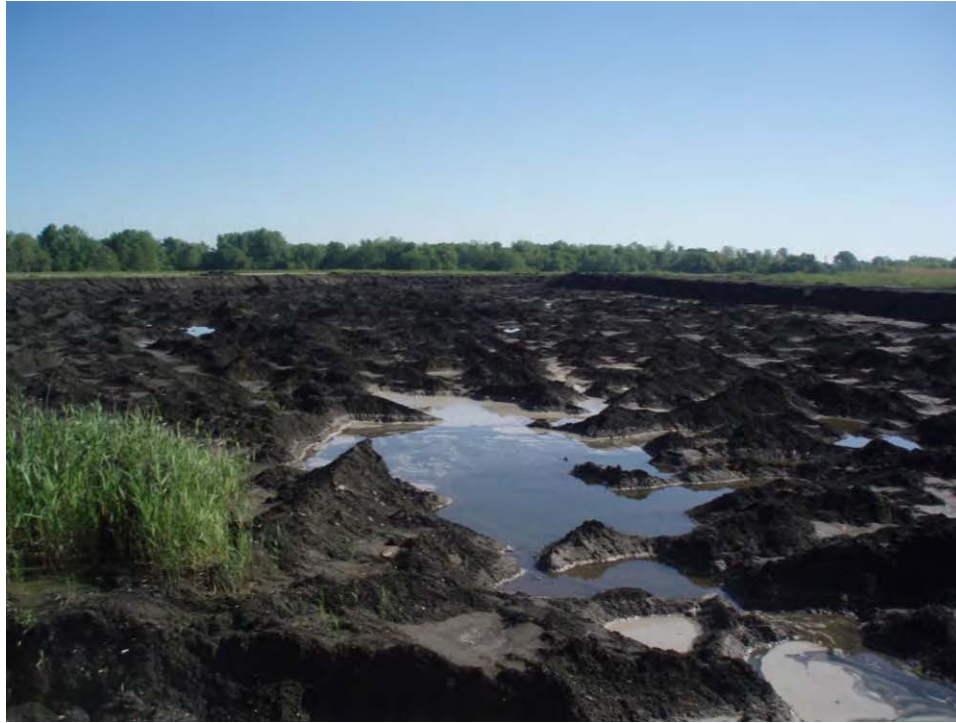
143. Overview of Pond C, looking northeast.

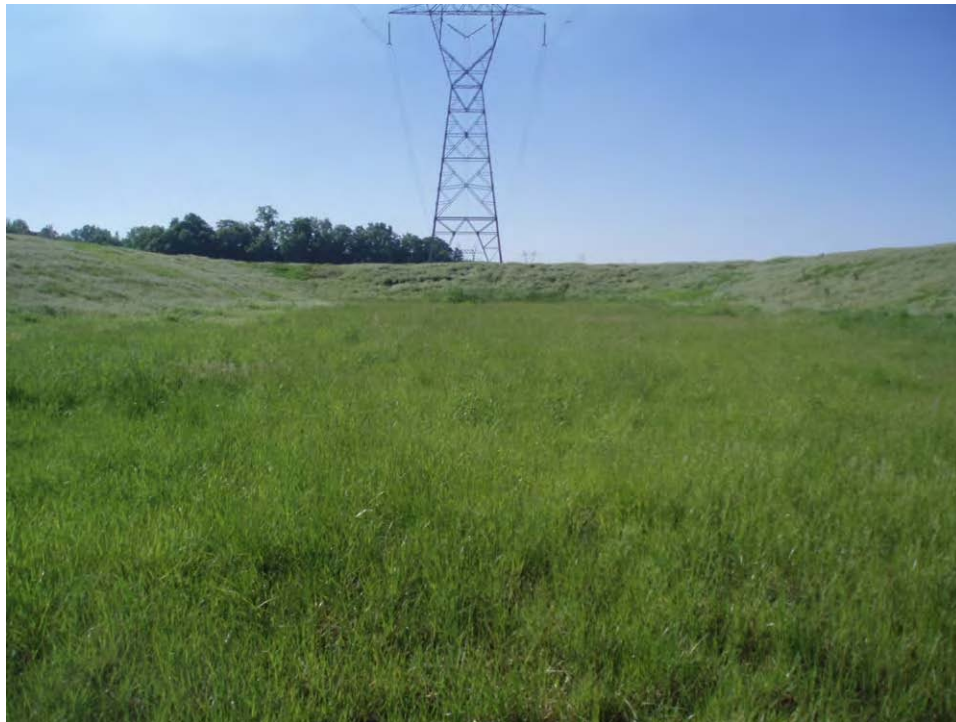
144. Low area between Pond B and Pond C, looking north at embankment between two impoundments. Note the equalizer pipe runs through the embankment.

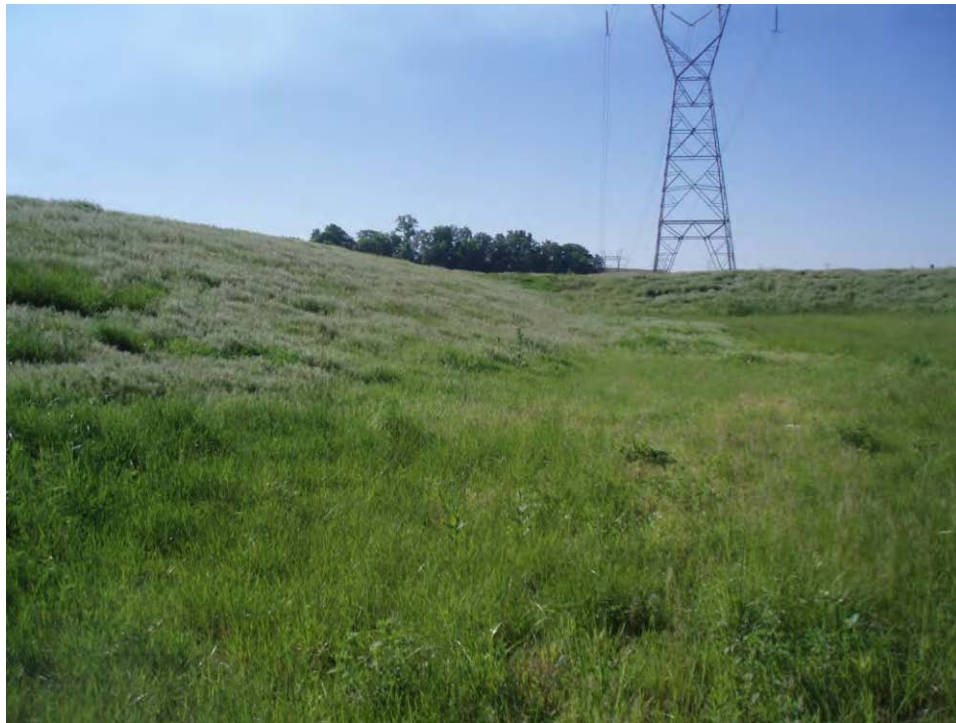
145. Pond C - South embankment exterior slope, looking southeast.

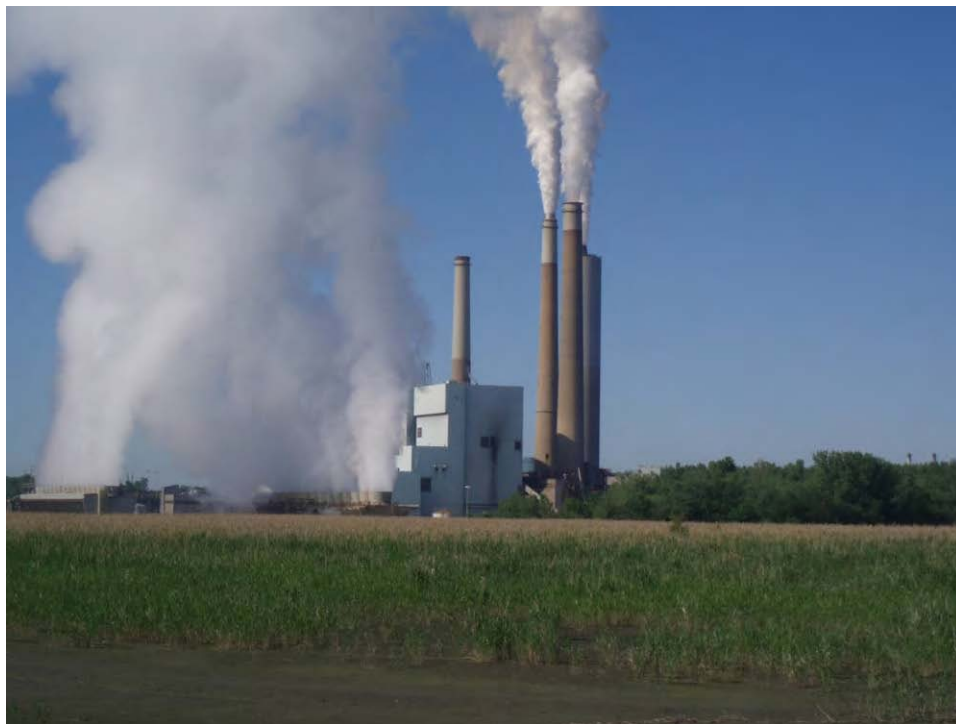
147. Overview of Pond B from north embankment, looking southwest.
